ACR Guidance Document on MR Safe Practices: 2013

Key Words: MR safety; MR; MR safe practices
J. Magn. Reson. Imaging 2013; 000:000–000.
 © 2013 Wiley Periodicals, Inc.

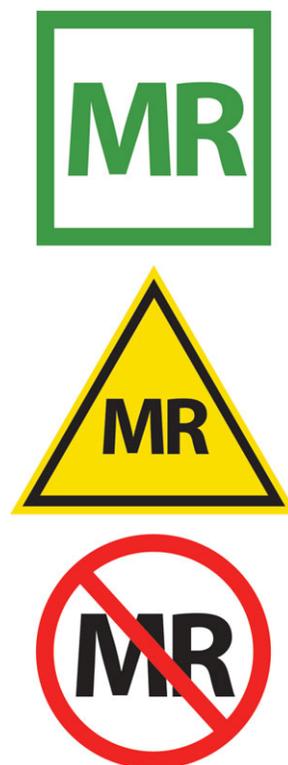
Figure 2. U.S. Food and Drug Administration labeling criteria (developed by ASTM [American Society for Testing and Materials] International) for portable objects taken into Zone IV. Square green “MR safe” label is for wholly nonmetallic objects, triangular yellow label is for objects with “MR conditional” rating, and round red label is for “MR unsafe” objects.

- a. All portable metallic or partially metallic devices that are on or external to the patient (e.g., oxygen cylinders) are to be positively identified in writing as MR Unsafe or, alternatively, MR Safe or MR Conditional in the MR environment before permitting them into Zone III Figure 2. For all device or object screening, verification and positive identification should be in writing. Examples of devices that need to be positively identified include fire extinguishers, oxygen tanks and aneurysm clips.

erly identified and appropriately labeled using the current FDA labeling criteria developed by ASTM International in standard ASTM F2503 (<http://www.astm.org>). Those items which are wholly, nonmetallic should be identified with a square green “MR Safe” label. Items which are clearly ferromagnetic should be identified as “MR Unsafe” and labeled appropriately with the corresponding round red label. Objects with an MR Conditional rating should be affixed with a triangular yellow MR Conditional label before being brought into the scan room/Zone IV.
